# **Final report no. 2430 of the Swiss Transportation Safety Investigation Board STSB**

concerning the accident of the helicopter  
Bell 505 Jet Ranger X, HB-ZWC,

on March 12, 2024

Egg, 3 km south of Weinfelden, municipal-  
ity of Bussnang (TG)

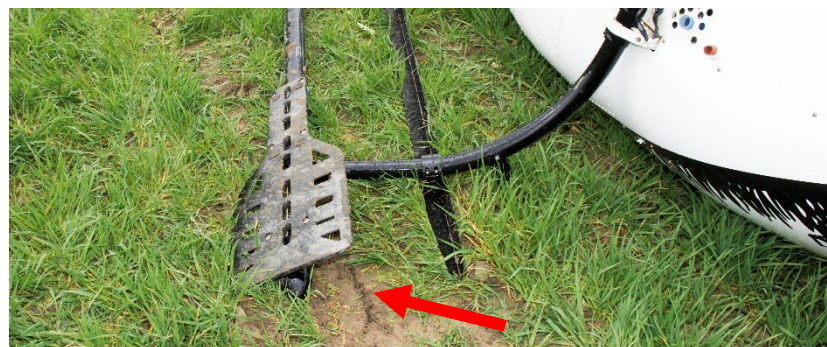
The bear paw of the right skid was turned markedly inwards. A ground scar was visible close to the bear paw of the right skid which had been pressed sideways into the ground (see Figure 4 ).

**Figure 4 :** Right skid with bear paw turned markedly inwards. A ground scar caused by the bear paw pressed laterally into the ground can be seen in the ground (red arrow).

The right bear paw was found markedly rotated inwards, the left bear paw slightly rotated inwards (cf. Figure 4 ).

- Loose bolt connections of the bear paws, which led to the right-hand bear paw twisting, getting stuck in the ground and thus becoming the pivot point of the dynamic rollover.
- The combination of wind speeds within the range of the translation speed, a wind direction from the front left quadrant, a high landing gear and a high-power reserve due to the low mass of the helicopter.

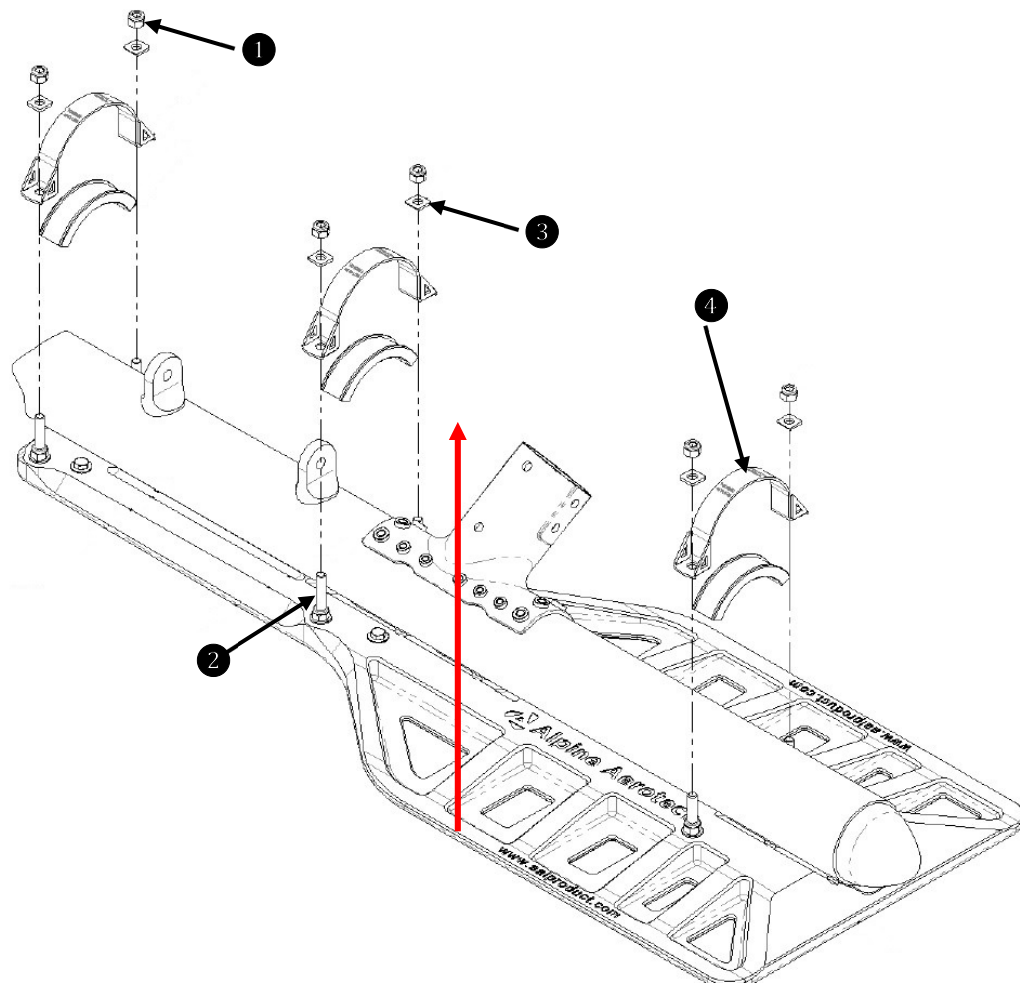
Furthermore, the STC holder specifies that the self-locking fastening nuts (see Figure 5, No. 1) should only be tightened evenly with a torque wrench to 40 in/lb once the helicopter is back on the ground. It is important to note that a thin-walled socket is required to properly tighten the self-locking fastening nuts. The fastening straps (strap assy; see Figure 5, No. 4) are labeled with this tightening torque, although the writing was difficult to read.

**Figure 5 :** Assembly drawing of the bear paw with fastening nut ①, screw ②, washer ③ and fastening bracket ④. The red arrow indicates the point at which the force to turn a bear paw around the longitudinal axis of the runner was measured. Source: ICA of the STC holder.

When the helicopter was raised, the bear paws on the left and right skids could be rotated by hand around the longitudinal axis of the respective skid with little effort. According to the STC holder Alpine Aerotech, the force required to turn a properly tightened bear paw around the longitudinal axis of the skid should be around 220 to 270 N (measured with a spring balance on the outer edge of the bear paw, see

red arrow in Figure 5 ). This value is not noted in the technical documentation (see chapter 1.4.2 and chapter 1.4.4). In this case, the required force was around 20 N.

On the bear paws of the left and right skid, the washers on the 12 bolted connections could be partially moved by hand. The fastening nuts on all bolted connections were turned almost equally onto the bolts or there was the same amount of play between the washers and nuts.

The measured torque for all bolted connections was between 1.5 Nm and 2 Nm (corresponding to 13.3 in/lb and 17.7 in/lb), which corresponds to the tare torque for this type of bolted connection.

Based on the findings of the bolted connections on the bear paws, it can be concluded that all self-locking fastening nuts of the bear paws were not tightened to the correct final torque, consisting of the friction drag torque or tare torque and the desired torque or recommended torque of 40 in/lb.

The torque value found on the bolted connections corresponded only to the tare torque for this type of fasteners. Whether this was due to the use of an unsuitable socket wrench insert with an excessively thick wall, contrary to the STC holder's instructions in the installation and maintenance documents, or due to an incomplete installation process, remains open.

According to the STC holder, the force required to turn a bear paw on the skid tube should be between 220 and 270 N. However, this value was not mentioned in the installation and maintenance documents. A corresponding checklist item on the installation instructions and in the flight manual supplement would most likely have made it possible to detect the loosely installed bear paws, which is why the STSB issues a safety advice (see chapter 4.2.1).
